Sewerage & Water Board OF NEW ORLEANS

Re: Sewerage and Water Board of New Orleans (SWBNO)
LSP Incident No. 18-03596
National Response Center Incident No. 1220212

**SUMMARY OF DIESEL SPILL
FLORIDA AVENUE CANAL
AUGUST 1-9, 2018
FINAL REPORT**

E.A.D. INVESTIGATOR'S REPORT

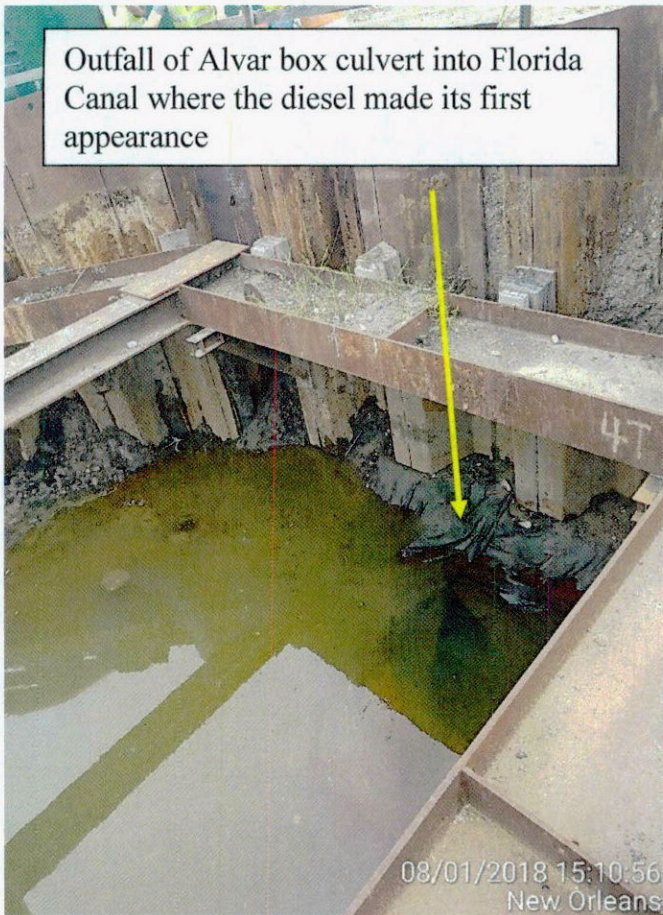
Outfall of Alvar box culvert into Florida Canal where the diesel made its first appearance

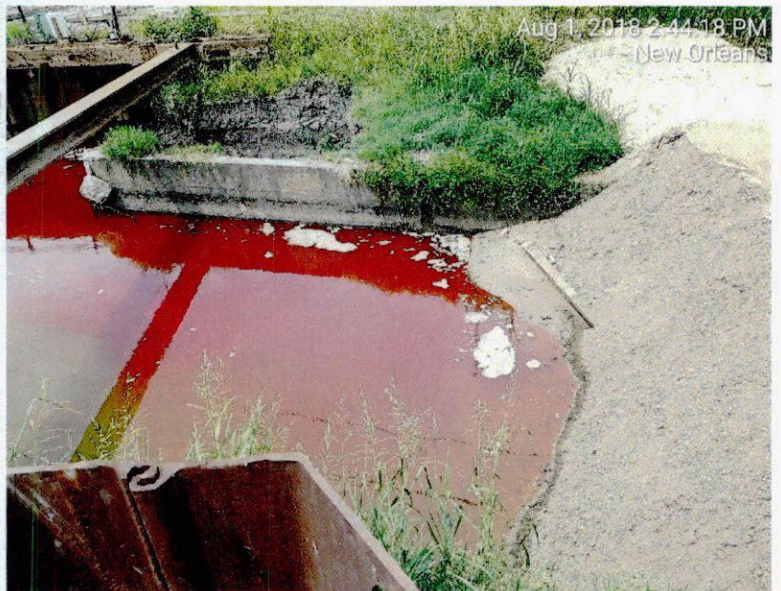
Diesel pooling at Boh Bros. sand dam

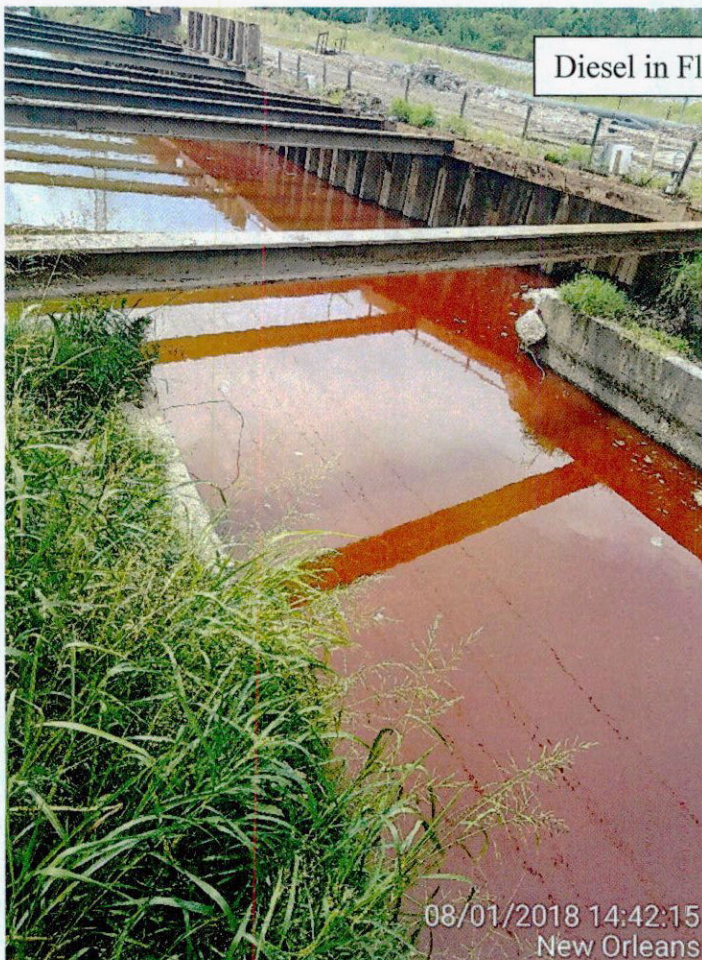
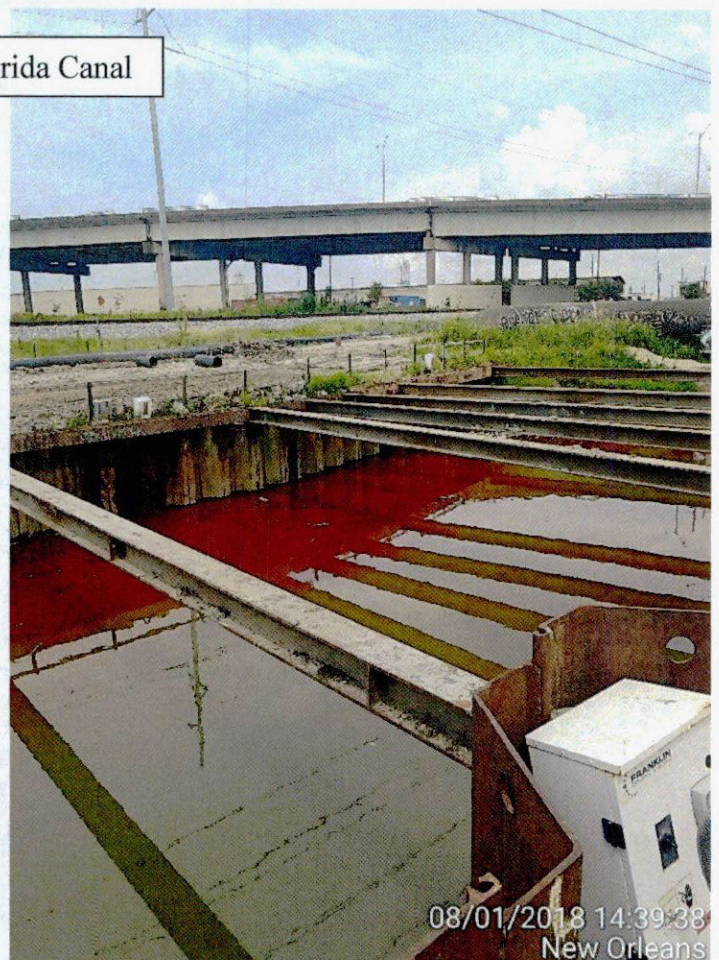
Diesel in Florida Canal

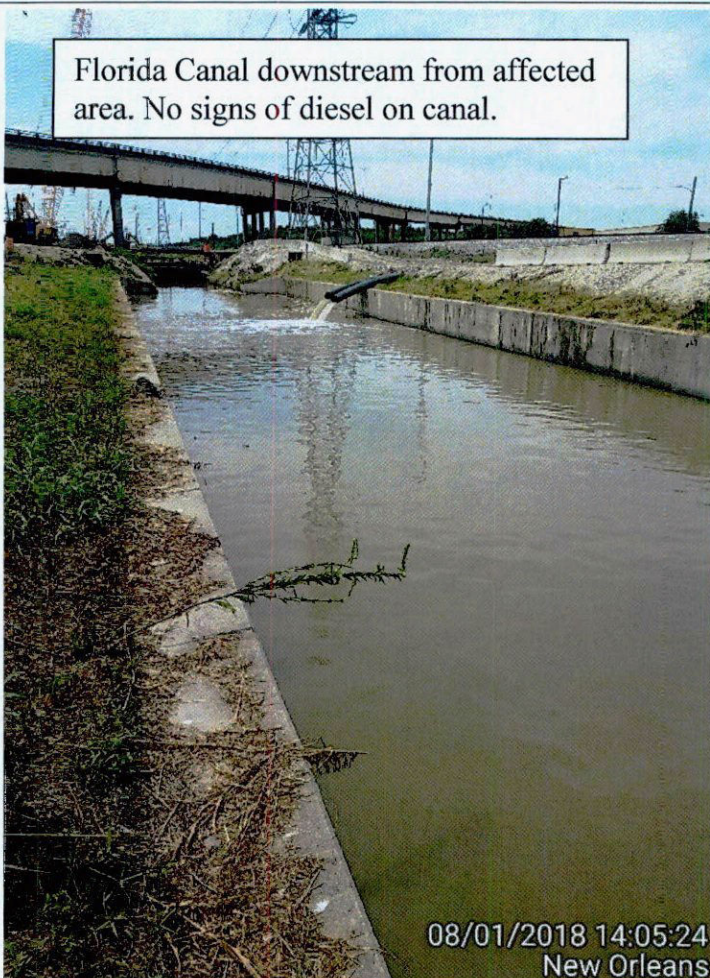
Florida Canal downstream from affected area. No signs of diesel on canal.

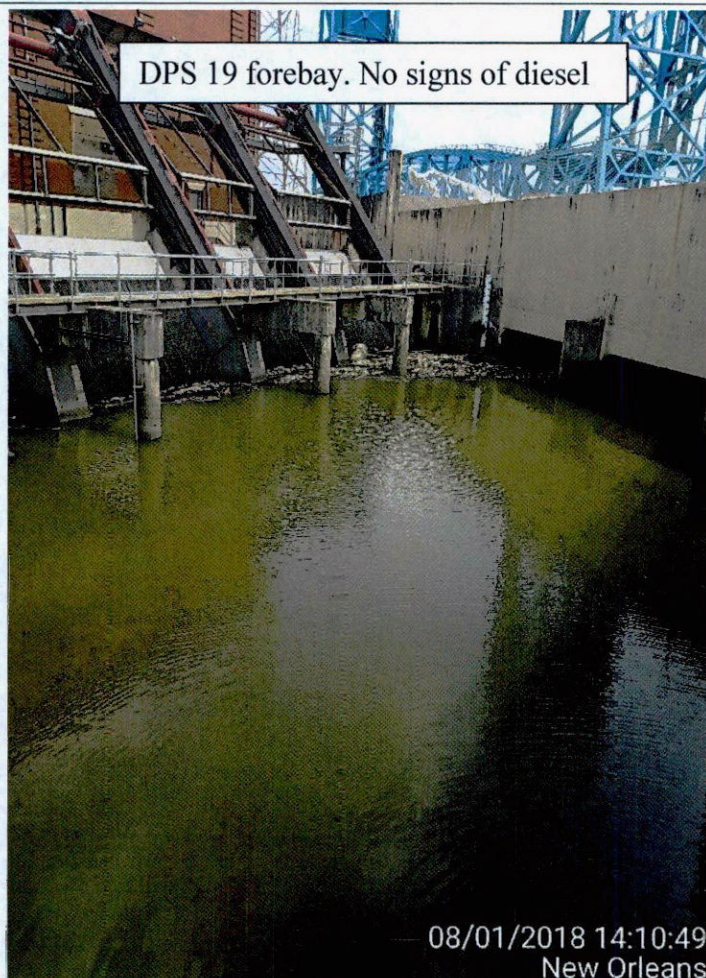
DPS 19 forebay. No signs of diesel

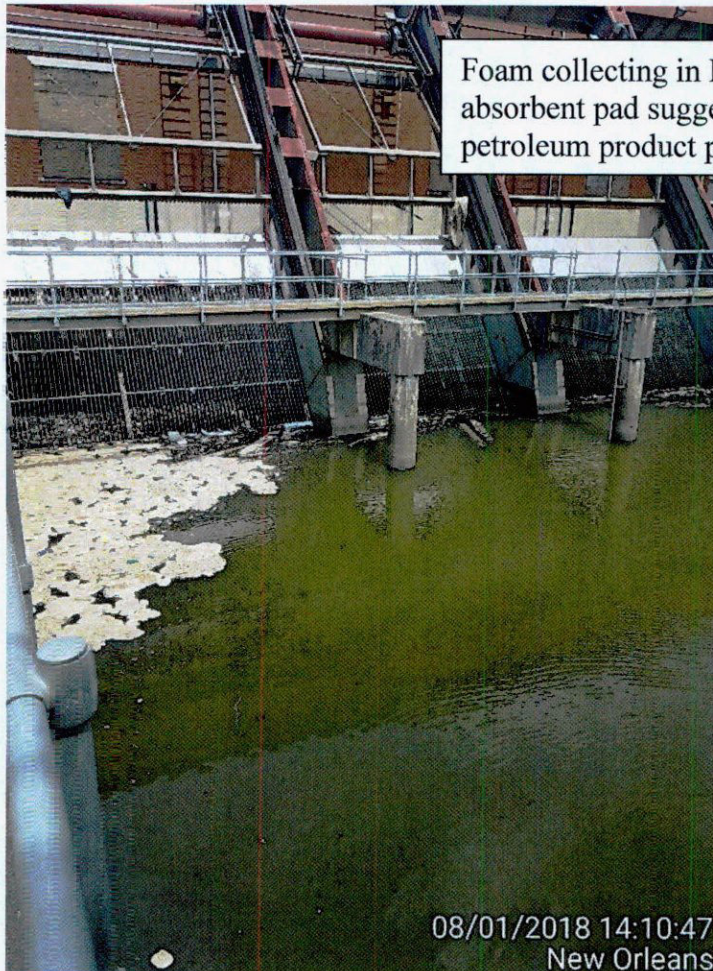
Foam collecting in DPS 19 forebay, oil absorbent pad suggested there was no petroleum product present

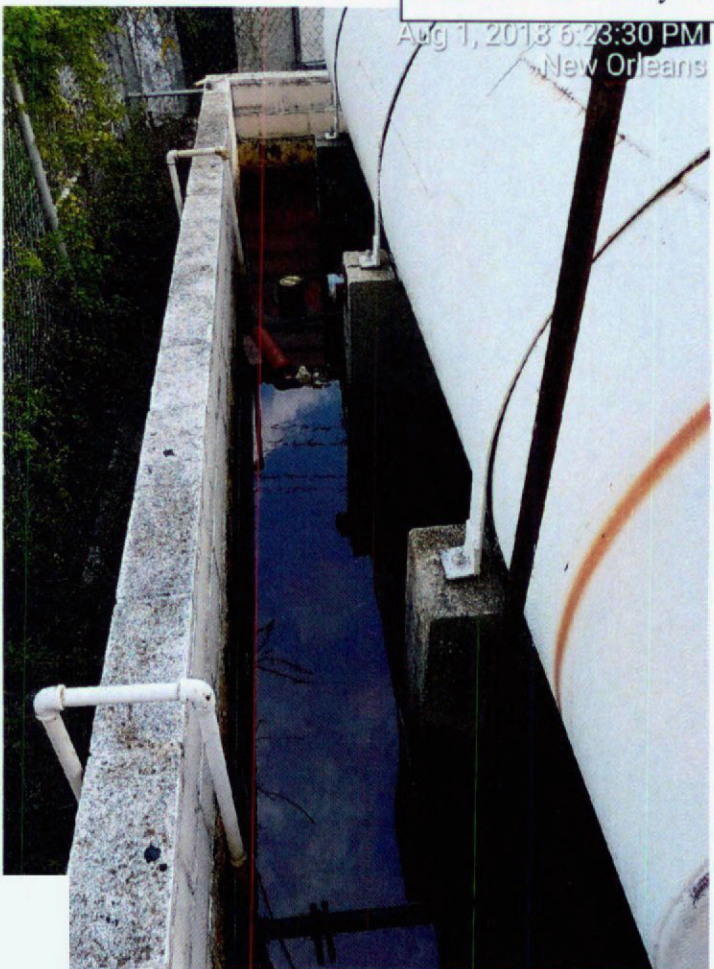
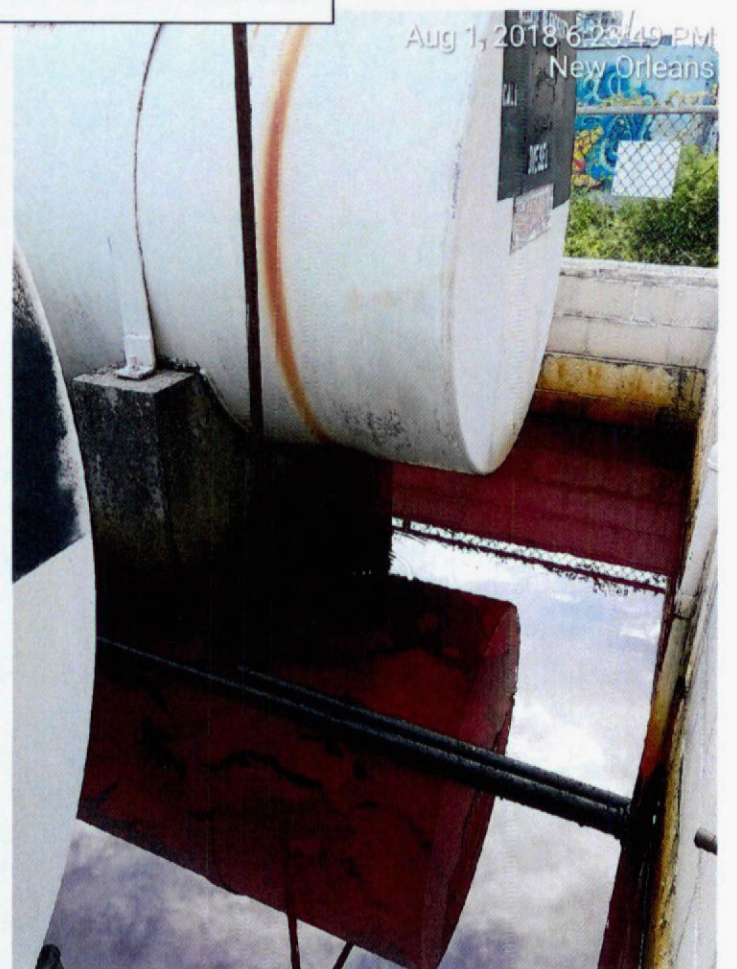
Trespassers scrapping material from the abandoned Naval Base on Poland Avenue removed brass plugs from the bottom of two roughly 2000 gallon storage tanks which emptied their contents into non-watertight secondary containment, then into the drainage system and eventually to the Florida Canal and Drainage Pump Station 19. None of the product was discharged past the drainage pump station.

Diesel in secondary containment at source site

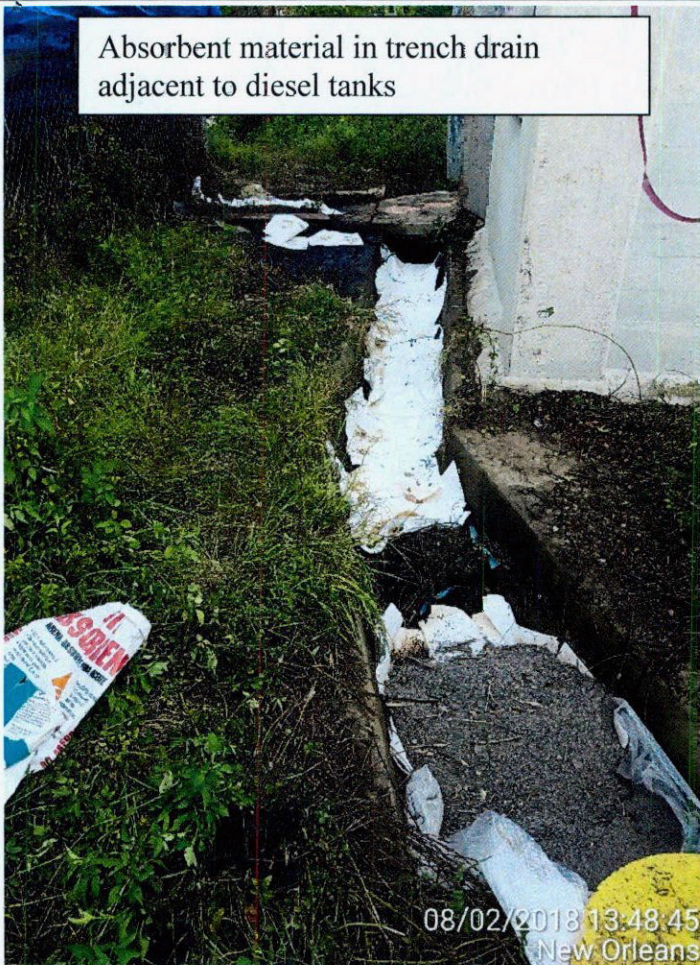
Absorbent material in trench drain
adjacent to diesel tanks

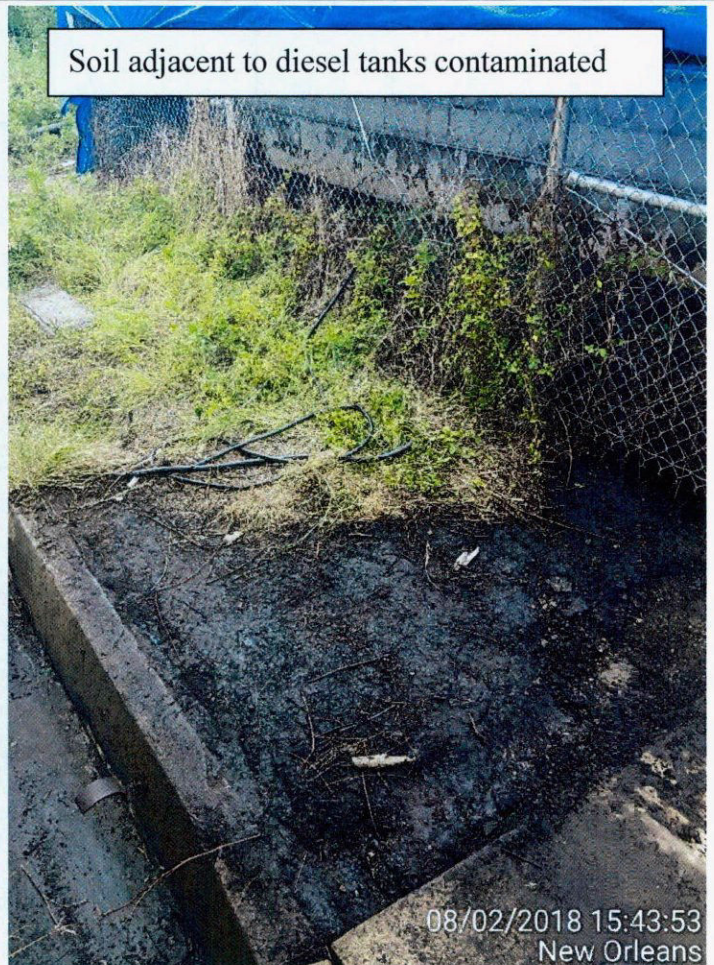
Soil adjacent to diesel tanks contaminated

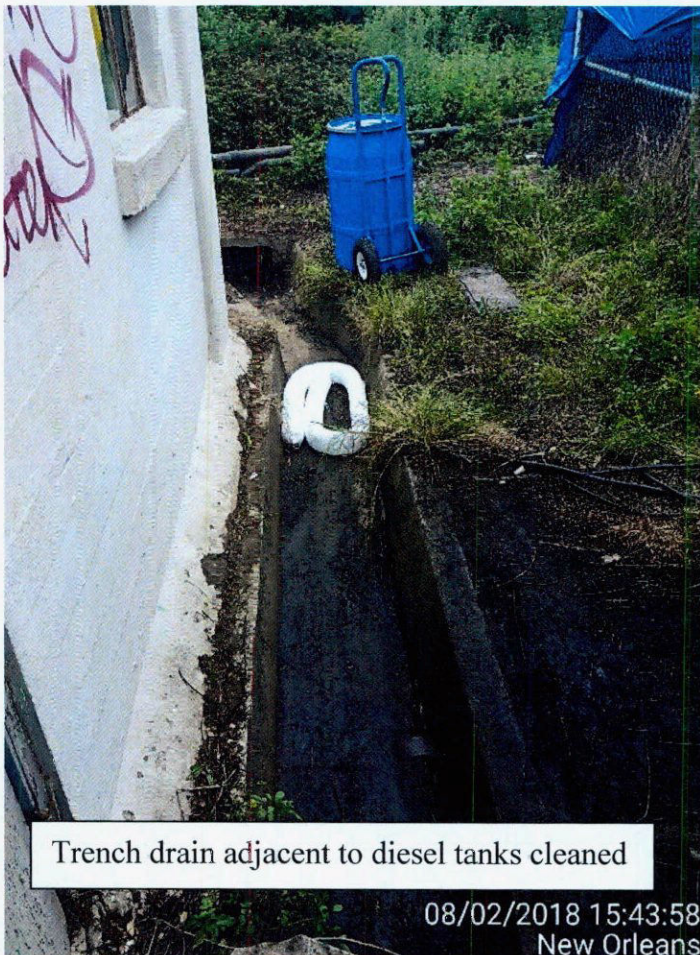
Trench drain adjacent to diesel tanks cleaned

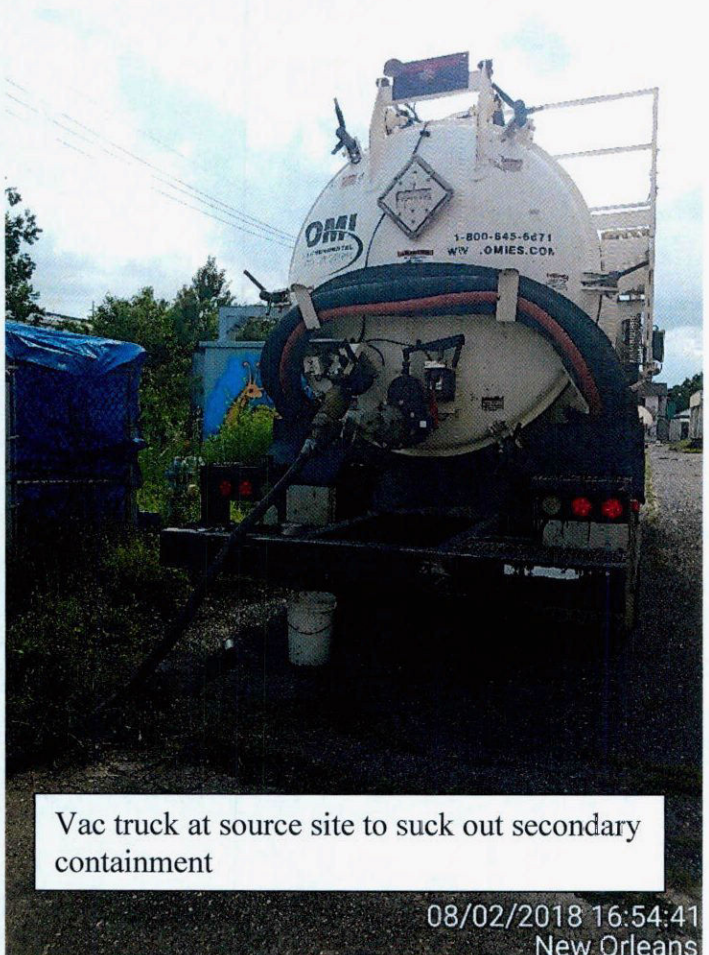
Vac truck at source site to suck out secondary
containment

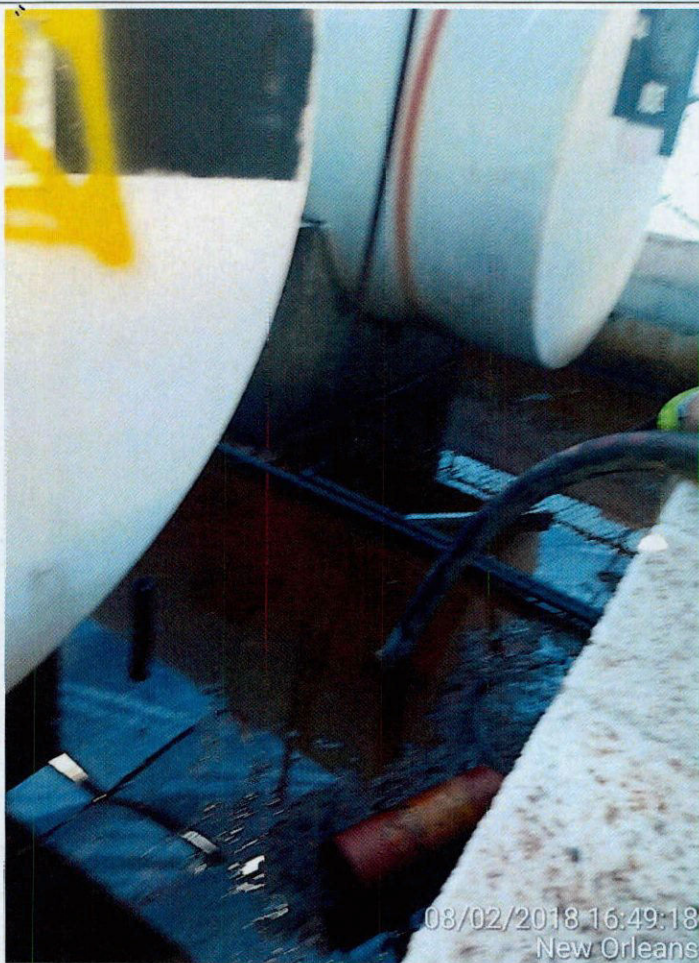
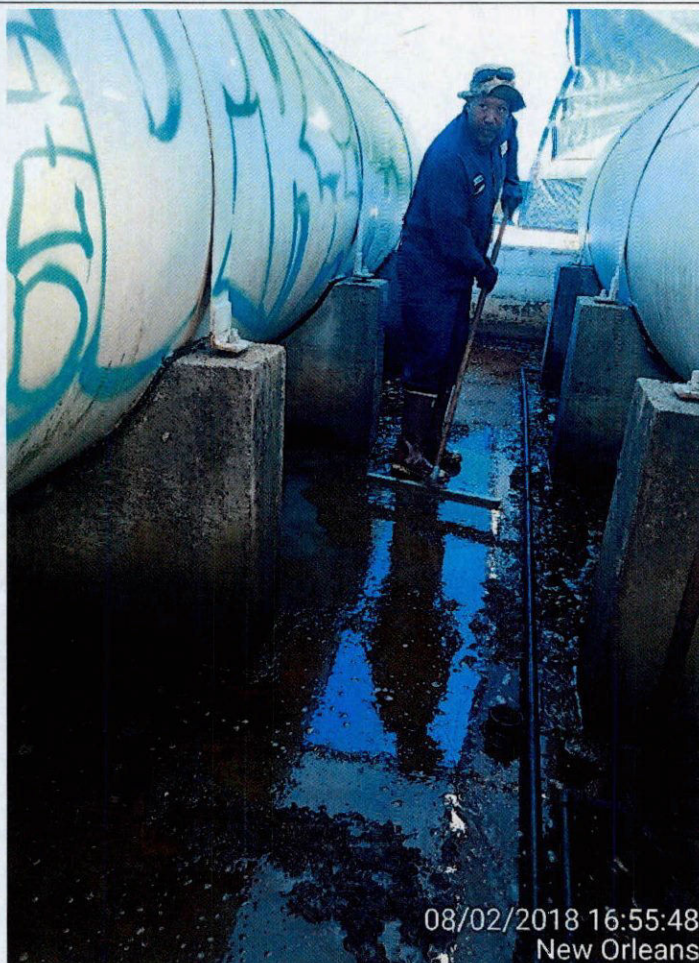
OMI cleaning out diesel in secondary containment at the source site

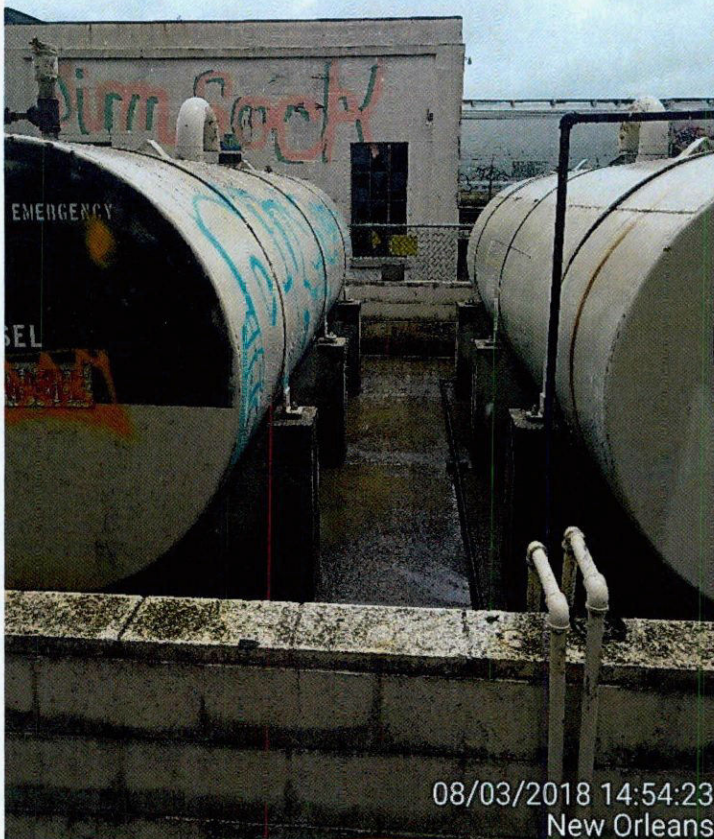
Secondary containment cleaned and residual product in tanks sucked out

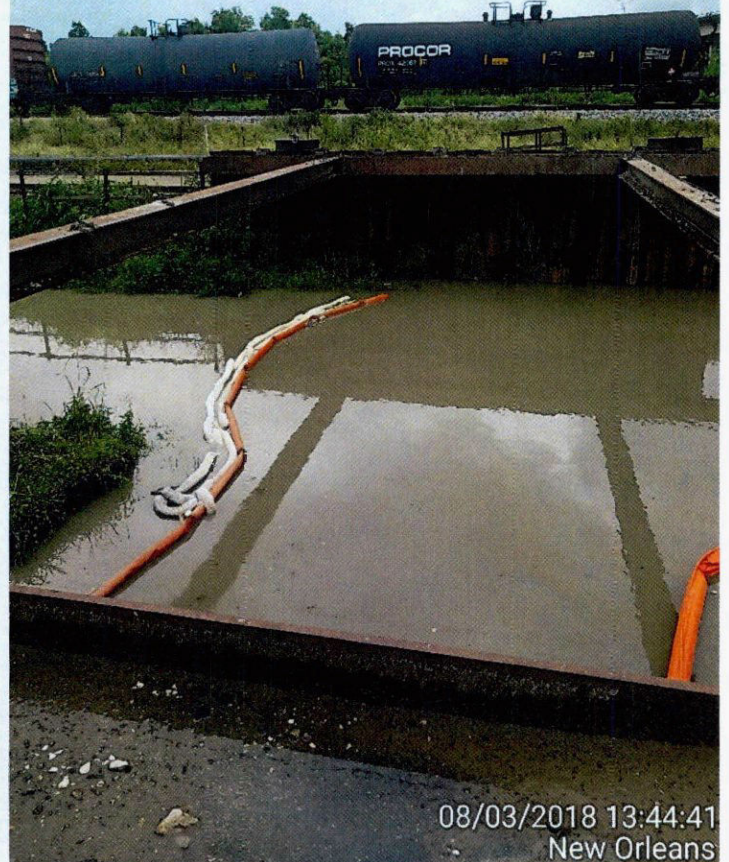
Soft and hard boom in Florida Canal

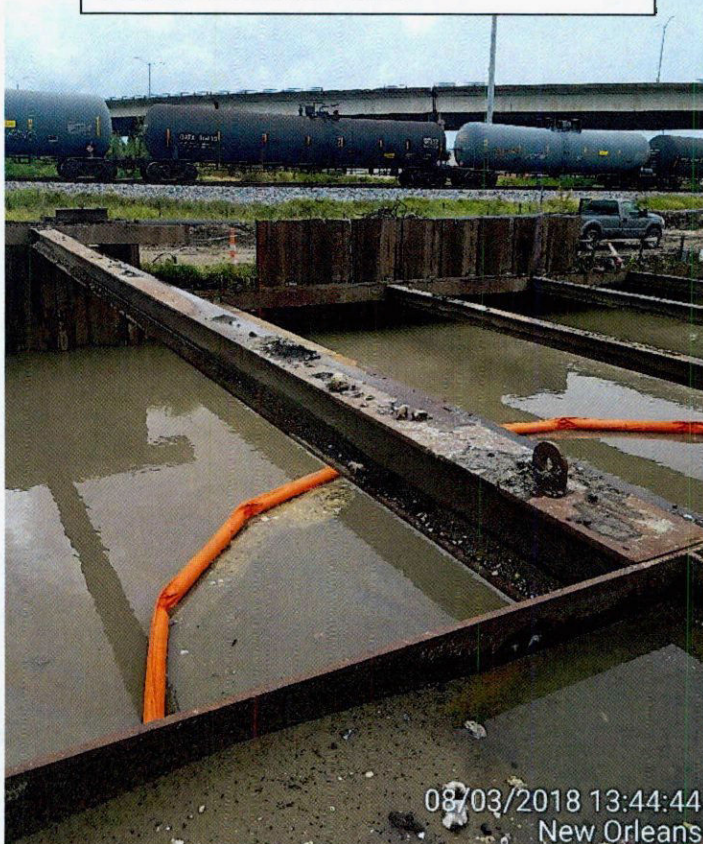
Boom capturing inflow from Alvar box culvert in Florida Canal

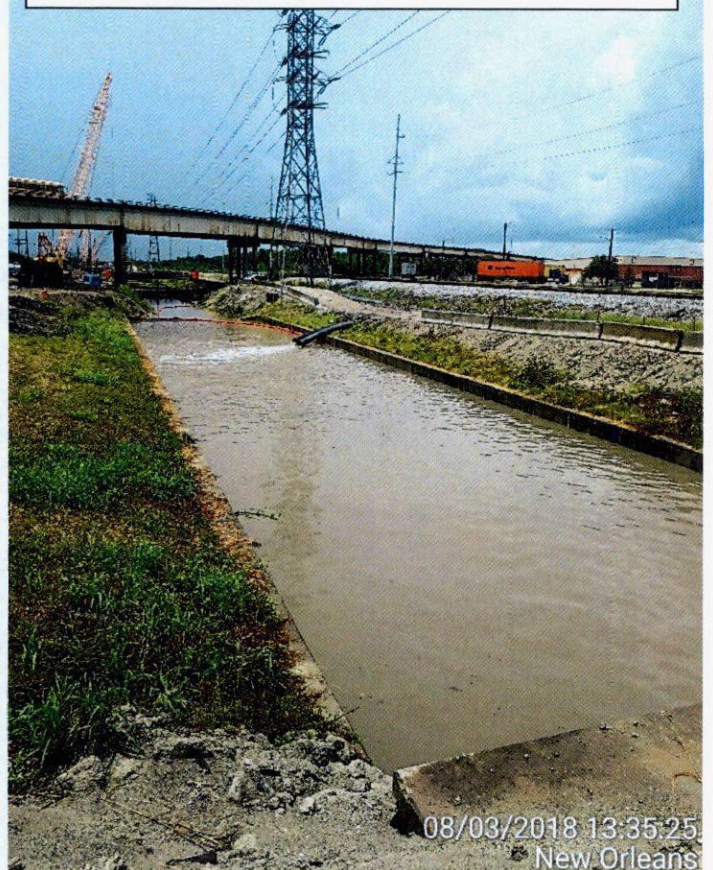
Florida Canal downstream from affected area

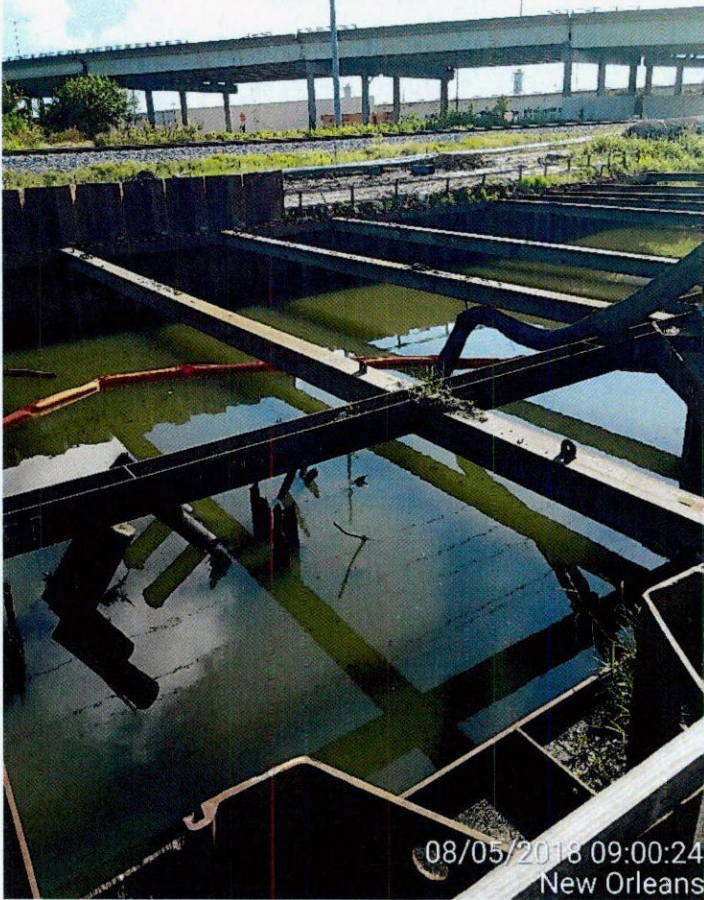
Boom at Alvar box culvert outfall intact

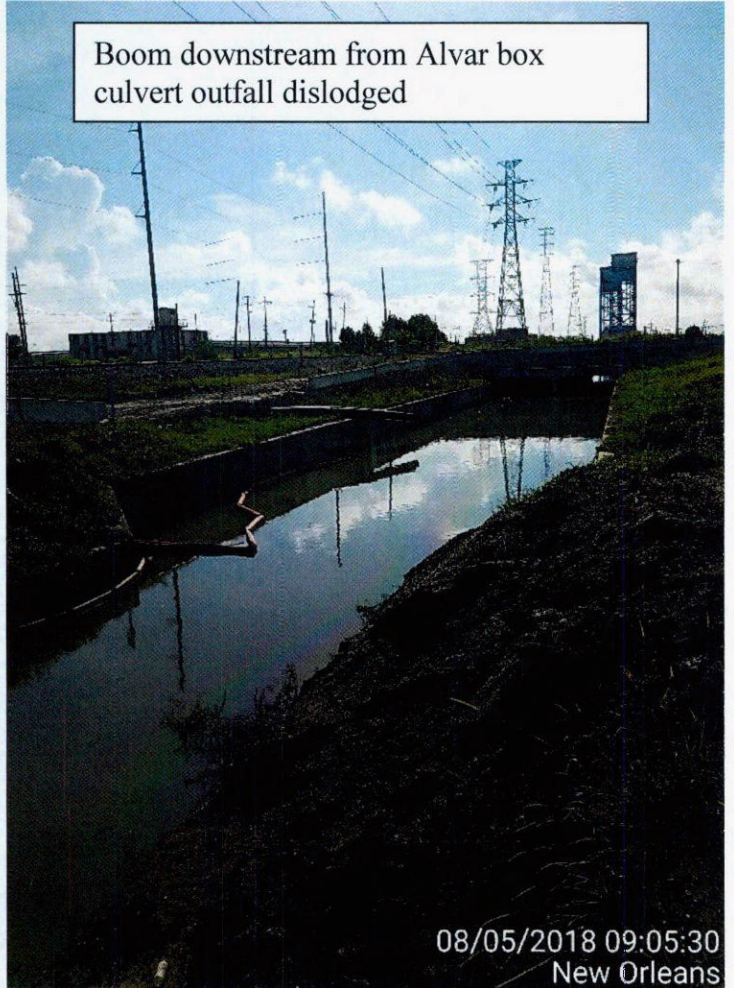
Boom downstream from Alvar box culvert outfall dislodged

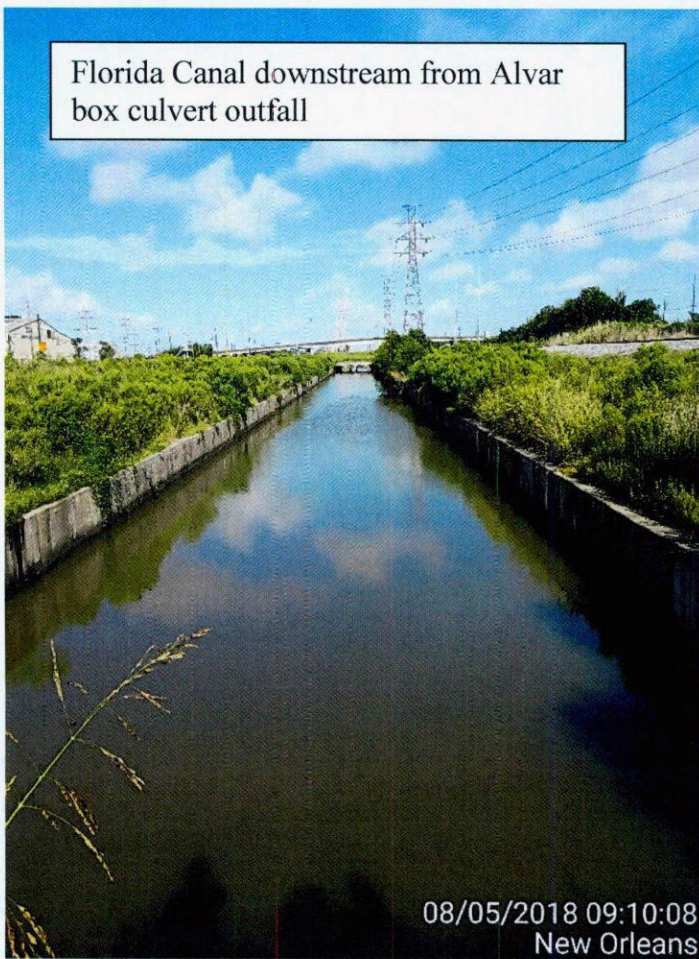
Florida Canal downstream from Alvar box culvert outfall

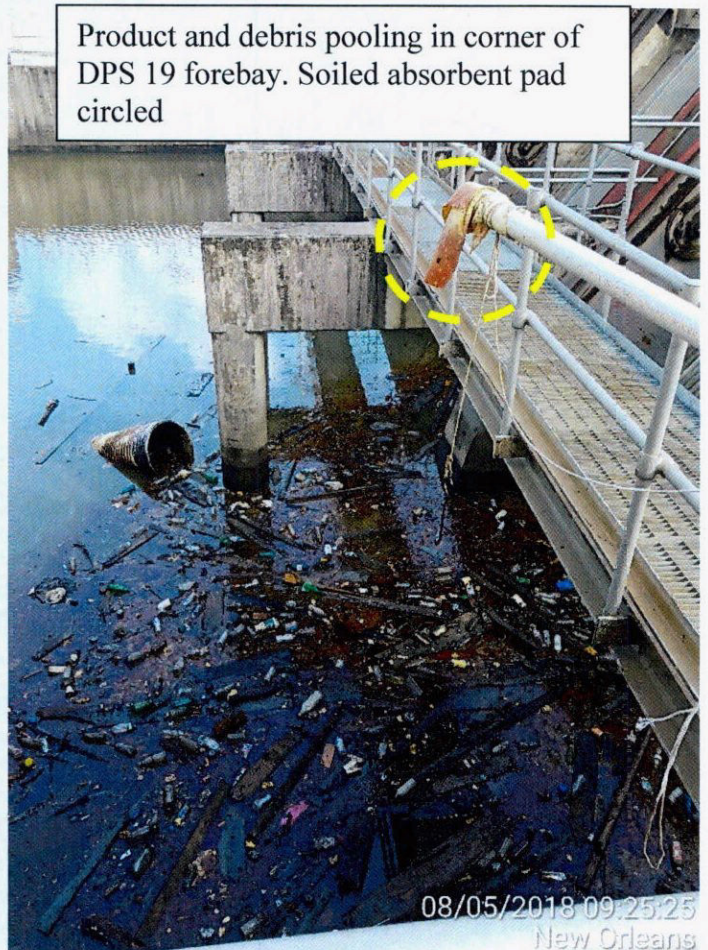
Product and debris pooling in corner of DPS 19 forebay. Soiled absorbent pad circled
